# IDENTIFICATION OF PROBLEMS IN RIGID PAVEMENTS IN AMPARA DISTRICT AND PROPOSED SOLUTIONS

**ABSTRACT:** Construction of rigid pavements is nowadays most widely used in road construction industry. Rigid pavements tend to fail with time due to many reasons. Although the reasons for the failures and the remedial measures are well documented in literature still the problems are common in the road construction industry of Sri Lanka. Hence, the aim of the present study is to shed some light on this issue. The objective of the present study is to identify the problems associated with rigid pavements and recommended solutions in Ampara district, Sri Lanka. Through literature survey, problems in rigid pavements and how to identify them were found. Then 108 randomly selected rigid pavements covering a total length of 98 km in Ampara district were examined by field survey to identify the problems present in recently constructed rigid pavements. The failure types were identified with the help of literature survey and the exerted reasons on the failures were studied. Altogether 10 types of various failures were identified in randomly selected all rigid pavements, and 5 major types of failures

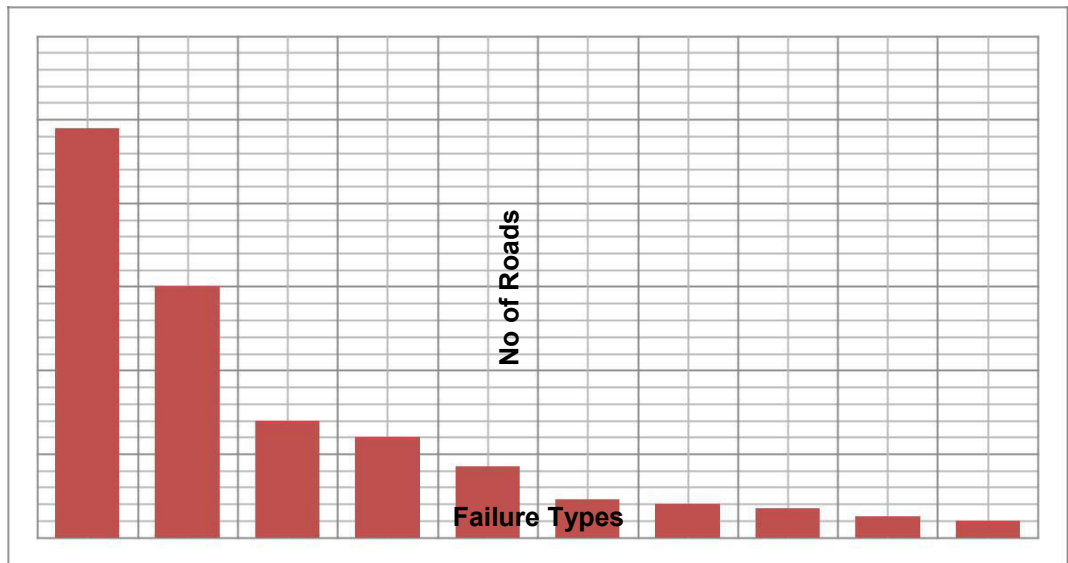
Figure1. Severity of different types of failure

Altogether 10 different types of failures were identified in 108 roads from the field survey and shown in Figure 1 below.

The above bar chart illustrates the different types of failures found in rigid pavements in Ampara district. Polished Aggregates was the most severe failure type as it was identified in most number of roads. Map cracking was the less significant failure pattern as it was found in only 4 roads. Some of roads have multiple failures too. Among those failures first 5 types of failures shown in Figure 1 were reported as most significant, and were focused in this paper and discussed below with the causes, and proposed solutions.

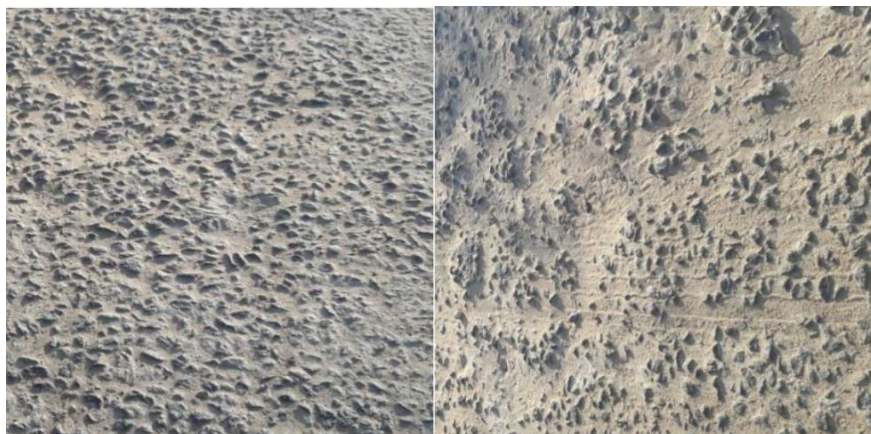
Figure2. Polished Aggregates

This is the most significant problem identified in rigid pavements in Ampara district from the field survey. Almost 90% of roads have failed by the polished aggregates. When examining the failure surface shown in Figure 2, coarse

aggregates exposed to environment as fine particles removed from the surface due to vehicle abrasion. The main causes are usage of poor quality cement which does not have good abrasion resistance and poor finishing. Based on the questionnaire survey it was revealed that most of the labourers were not trained well and poor supervision of construction activities particularly in finishing during the construction. This problem can be rectified by overlaying asphalt layer over the existing concrete surface.

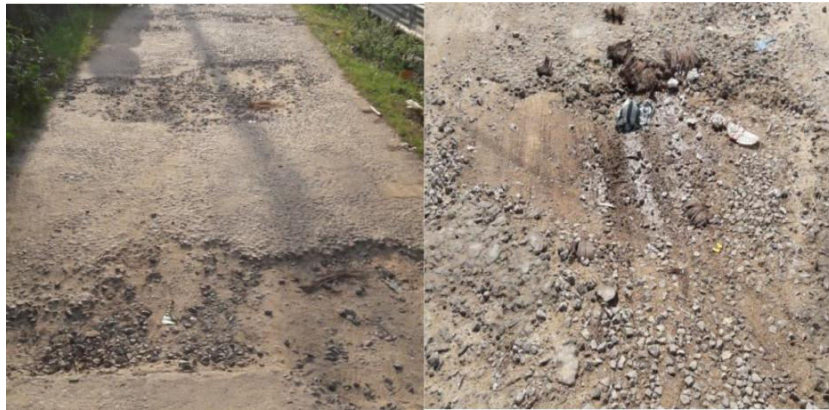
*Figure3. Scaling*

This problem shown in Figure 3 was reported as the second major failure type followed by polished aggregates in rigid pavements in Ampara district. Almost this problem found in 60 roads. When observing the failure areas, they appeared like a pot holes of around 1m diameter, and without top concrete layer. Sub grade inside the failure areas exposed to the environment and it gradually weakened due to vehicular load. Main cause was identified from the field survey that is concrete which had not been air-entrained and poor quality materials were used during construction. This problem can be temporarily prevented by laying the asphalt over the failure surface.

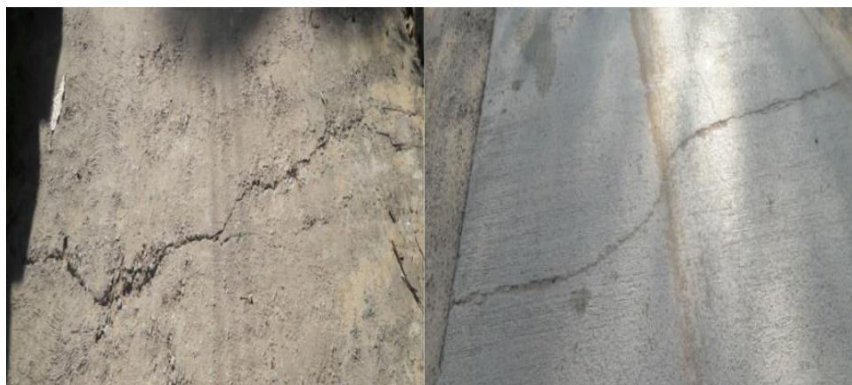
*Figure4. Transverse Cracking*

Crack patterns appeared in parallel to the transverse direction as shown in Figure 4 were found in 28 roads. When observing the failure no transverse joints were provided between adjacent slabs. Though design guidelines stated that the transverse joints should be placed in 6m intervals, transverse joints were found in 12m intervals in failed areas. This shows the ignorance of guidelines and poor construction practices of relevant agencies during construction. Removing the portion of cracked slab and placing transverse joints between two panels is the best rectify method for this problem.

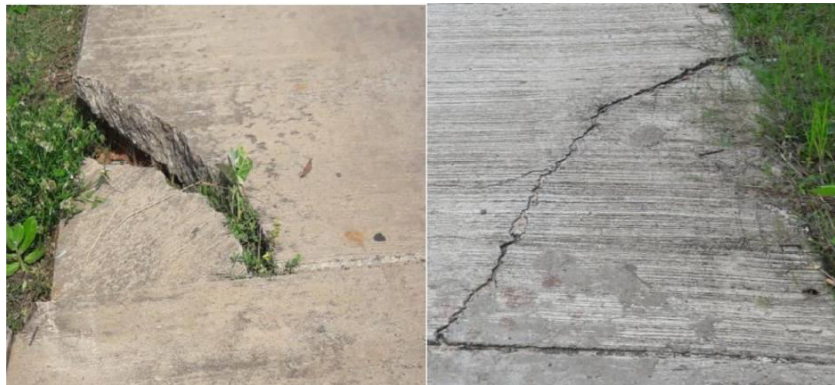
*Figure 5. Corner Breaks*

Corner breaks is the one of significant failure, and was identified in 24 roads. Portion of slab panel at the corner broke as shown in Figure 5 when it was observed during field survey. Main cause for this failure is high stresses acting at the corner of road due to trucks loaded heavily travelling on the edge of road. Furthermore, dowel and tie bars were not observed in the failure slab areas which are essential to connect the adjacent slabs. This shows the poor construction practices and lack of supervision during the construction. This problem can be rectified by providing dowels and tie bars through the cracked slab to adjacent slabs and concrete the failure portion again.

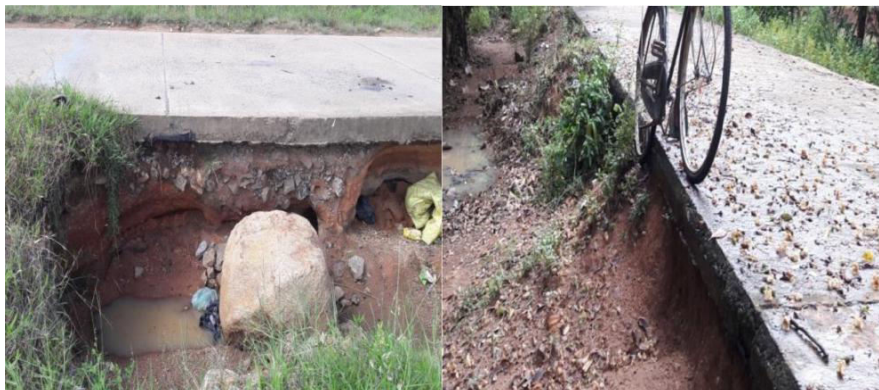
*Figure 6. Erosion of Sub Base*

This problem was identified in some part of the roads where the drainage facilities were not provided along the road as shown in Figure 6. Moreover some of failures were due to the improper embankment where road crosses the steep slope. Due to improper drainage flood water penetrates below the road surface and erodes the subgrade of road. This problem was identified in 17 roads. Constructing drainage network along the road is the one of the remedial action for this problem.
